Manhole Inspection Summary

Manhole # S05YY1016MH

Insp Date: **9/7/06 8:44 AM**

Location Address: **5909 HIGHGATE DR**

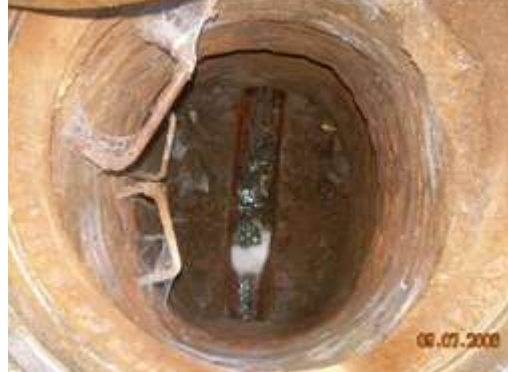
Top View

Frame leaks. Frame offset. Adjustent, Corbel and Barrel infiltration. Evidence of surcharge - Bench debris. Channel

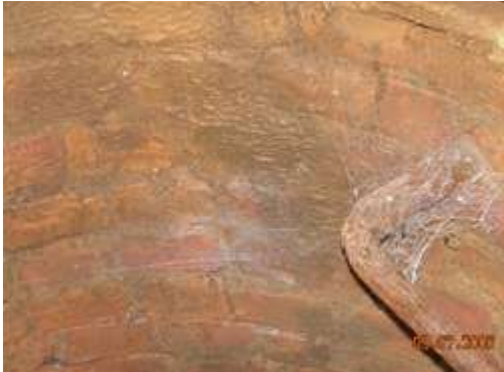
Defect

Adjustment and Corbel infiltration. Corroded steps.

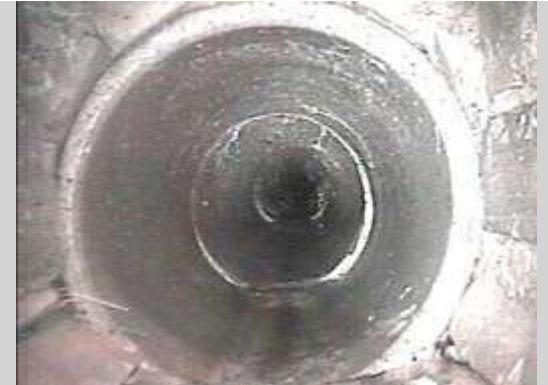
8 in. Circular Unknown Sewer Pipe Out @ 12 O'Clock

Channel root intrusion.

Infiltration: **Evidence** Pipe Seal Cond: **Cracked**

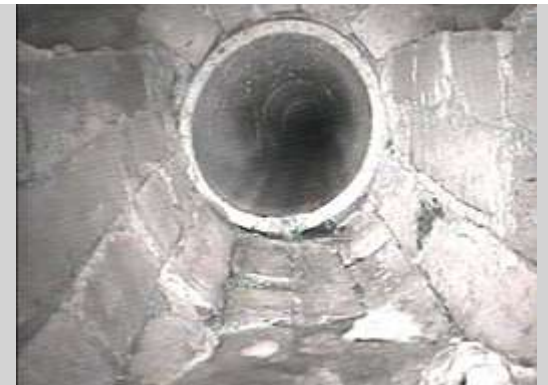
8 in. Circular Gravity Sewer Pipe In @ 6 O'Clock

Channel deterioration.

Infiltration: **Evidence** Pipe Seal Cond: **Unknown**
